**Flood Control Project Maintenance  
Levee Inspections**  
**LMA District Cover Sheet**  
**Spring 2019 Levee Inspection Results**

**Reclamation District No. 0563 Tyler Island**

**Spring 2019 Levee Inspection Results**

Waterway			Bank	Unit Miles
Unit No. 01 Georgiana Slough (Tyler Island)			Left	12.11
	Spring (March - May)	Summer (June - August)	(September - November) Fall	Winter (December - February)
Unit Maintenance Rating (Fall Only)				
Date of Inspection	4/5/2019 - 4/5/2019			
DWR Inspector	David Julian			
Accompanied By	Steve Mello RD 563

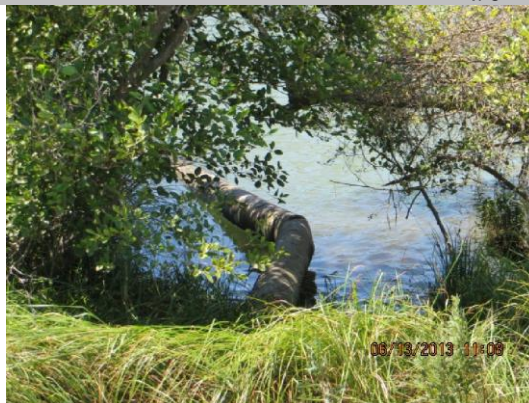
Photo 1 of 3 : UCIP\_SP\_2019\_16292\_27453.jpg

LM Start	8.88	Rating **	M	Issue No.	801
LM End	8.88	Issue Type +	En	Location *	
Category	Supplemental			GPS Latitude/Longitude	
				Start	End
Item	DWR UCIP Field Study			38.150420 °	38.150420 °
				-121.586840 °	-121.586840 °
DWR ID	20163				
Comment Code					
Inspector Comment					
FS_ID:16292 DS_ID:20163 EP_NO: 11217 Repair Type: Non-Urgent Crossing Status: Found UCIP Comments: Appears abandoned and should be done so properly. Slide gate broken. FIELD_STRUCT_DESC: 3 of 11: 14-inch steel irrigation pipe through the levee, 4.2 feet below the crown. Vent/filler pipe on the landside (LS) shoulder. Slide gate in 7-foot by 9-foot concrete distribution box on the LS toe. (Automatic Board Order (ABO) issued as Permit No. 11217, 1975 - Owen E. Wilkenson). [Additional Reference(s): DWR Levee Log, 2005. USACE Sacramento O&M Manual 103, June 1954, (Station ""L"" 171+57.5)]. FS Date: 6/13/2013

Pipe visible on WS toe. See damage to pipe at bend.

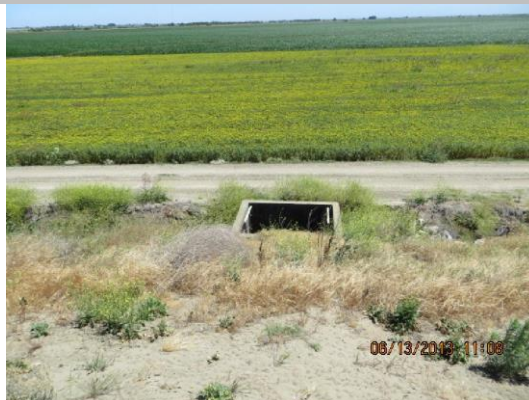
Photo 2 of 3 : UCIP\_SP\_2019\_16292\_27452.jpg

Concrete distribution box at LS toe.

Comment Code						
Inspector Comment						
FS_ID:16292 DS_ID:20163 EP_NO: 11217 Repair Type: Non-Urgent Crossing Status: Found UCIP Comments: Appears abandoned and should be done so properly. Slide gate broken. FIELD_STRUCT_DESC: 3 of 11: 14-inch steel irrigation pipe through the levee, 4.2 feet below the crown. Vent/filler pipe on the landside (LS) shoulder. Slide gate in 7-foot by 9-foot concrete distribution box on the LS toe. (Automatic Board Order (ABO) issued as Permit No. 11217, 1975 - Owen E. Wilkenson). [Additional Reference(s): DWR Levee Log, 2005. USACE Sacramento O&M Manual 103, June 1954, (Station ""L"" 171+57.5)]. FS Date: 6/13/2013

Broken slide gate in 7'X9' concrete distribution box on LS toe.

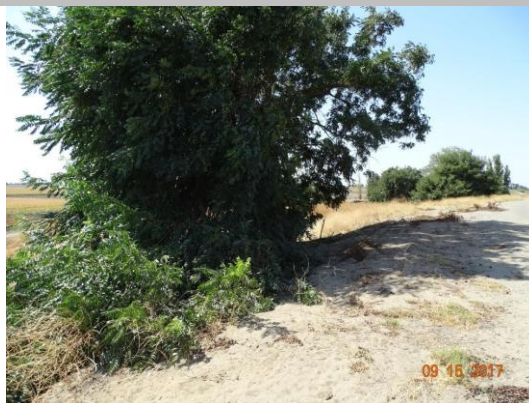
Photo 1 of 2 : SP\_2019\_RD0563\_210\_768\_20190311\_00121.jpg

LM Start	9.25	Rating **	M	Issue No.	768
LM End	9.25	Issue Type +	Ma	Location *	LS
Category	Earthen Levee			GPS Latitude/Longitude	
				Start	End
Item	Trim / Thin Trees			38.145897 °	38.145897 °
				-121.588203 °	-121.588203 °
DWR ID	DWR_RD0563_01_s_2015_768				
Comment Code					
T1 : Trim trees to at least five feet above ground level.					
Inspector Comment

Looking south at the landside slope.

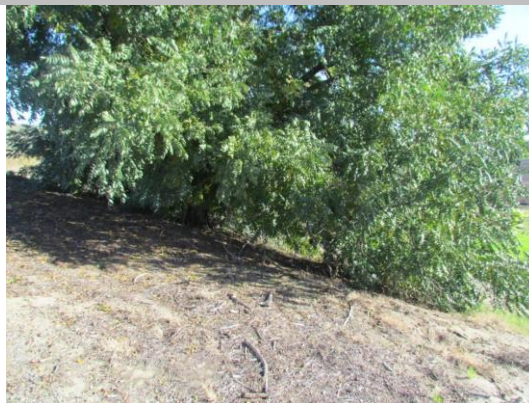
Photo 2 of 2 : SP\_2019\_RD0563\_210\_768\_20190311\_00122.jpg

Looking at untrimmed tree on landward slope.

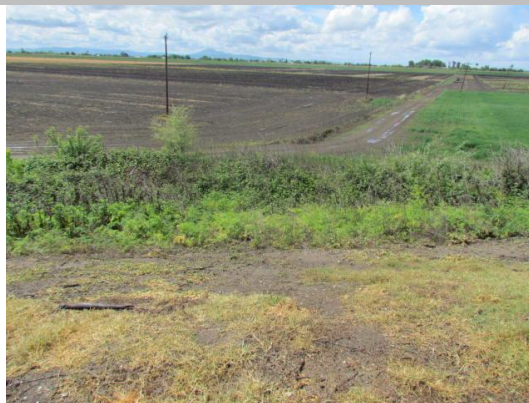
Photo 1 of 1 : SP\_2019\_RD0563\_210\_769\_20190311\_00123.jpg

LM Start	9.36	Rating **	M	Issue No.	769
LM End	9.43	Issue Type +	Ma	Location *	LS
Category	Earthen Levee			GPS Latitude/Longitude	
				Start	End
Item	Vegetation			38.146276 °	38.147034 °
				-121.590189 °	-121.590907 °
DWR ID	DWR_RD0563_01_s_2015_769				
Comment Code					
V2 : Remove the wild growth other than native grasses from the levee slopes.					
Inspector Comment

Looking east at dense vegetation at landward toe. (Spring 2015)

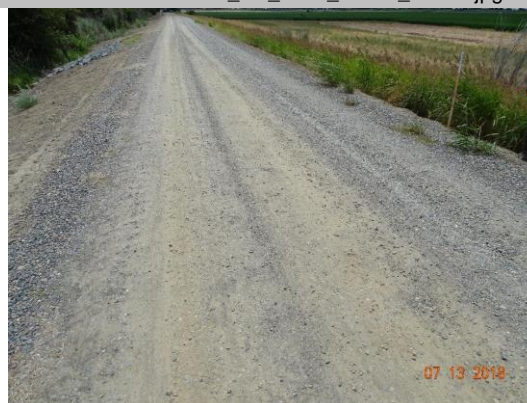
Photo 1 of 2 : UCIP\_SP\_2019\_52765\_77766.jpg

Comment Code					
Inspector Comment					
FS_ID:52765 DS_ID:20166 EP_NO: 11217 Repair Type: Non-Urgent Crossing Status: Found UCIP Comments: 06/13/2018 Appears abandoned as stand pipe is partially filled with soil. Abandon properly. No pictures taken. (W.Wylie) FIELD_STRUCT_DESC: 10-inch steel irrigation pipe through the levee, 3.8 feet below the crown. Vent/filler pipe on the landside (LS) shoulder. 4-foot-diameter concrete standpipe on the LS toe. (Automatic Board Order (ABO) issued as Permit No. 11217, 1975 - Owen E. Wilkenson). [Additional Reference(s): DWR Levee Log, 2005. USACE Sacramento O&M Manual 103, June 1954, (Station ""L"" 136+45.1)]. FS Date: 7/13/2018

View of levee crown at the crossing.

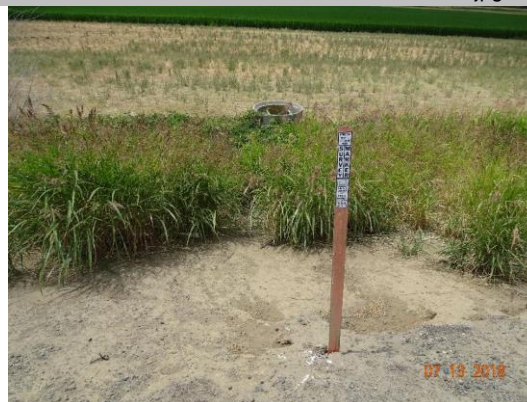
Photo 2 of 2 : UCIP\_SP\_2019\_52765\_77767.jpg

View of standpipe on LS.

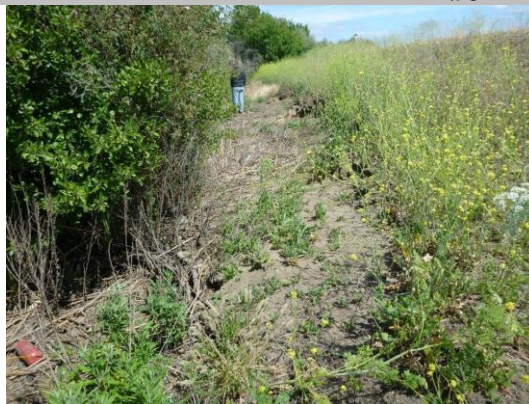
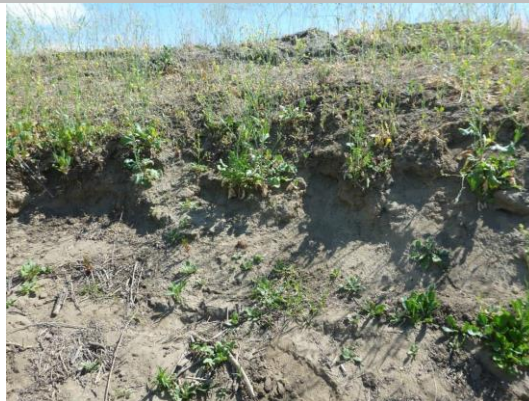
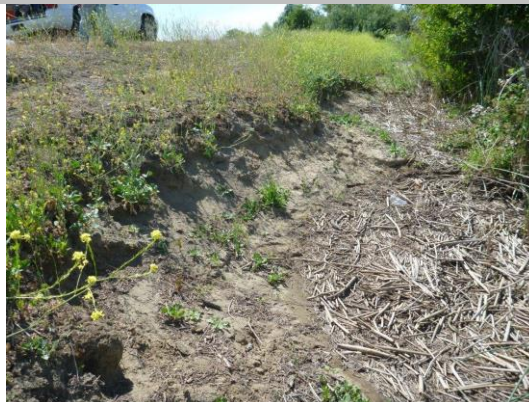
LM Start	9.73	Rating **	A/W	Issue No.	105	
LM End	9.78	Issue Type +	Ma	Location *		
Category	Supplemental			GPS Latitude/Longitude		
				Start	End	
Item	2017 Storm Damage			38.150820 °	38.151196 °	
				-121.593650 °	-121.594780 °	
DWR ID	DWR_RD0563_01_s_2018_105					
Comment Code						
Inspector Comment						
Levee Evaluation Comments						
Description:						
Site ID No:70						
Site Designation:DWR_RD0563_01_s_2012_49						
Repair Type: Erosion						
Rating:Serious						
Field Date:6/9/2017						
Notes:

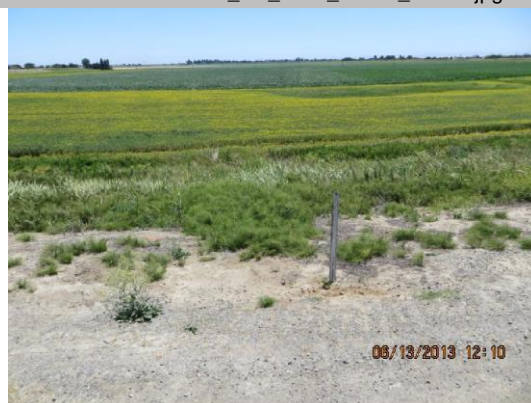
Photo 2 of 3 : UCIP\_SP\_2019\_52766\_24687.jpg

Comment Code						
Inspector Comment						
FS_ID:52766 DS_ID:20167 EP_NO: 11217 Repair Type: Non-Urgent Crossing Status: Found UCIP Comments: 07/13/2018 Fall hazard: 5-foot-diameter steel standpipe on LS needs to be covered. (O.Yakimov-DWR UCIP) FIELD_STRUCT_DESC: 14-inch steel irrigation siphon pipe through the levee, 4.3 feet below the crown. Vent/filler pipe on the landside (LS) shoulder, and a slide gate in a 5-foot-diameter steel standpipe at the LS toe. (Automatic Board Order (ABO) issued as Permit No. 11217, 1975 - Owen E. Wilkenson). [Additional Reference(s): DWR Levee Log, 2005. USACE Sacramento O&M Manual 103, June 1954, (Station ""L"" 119+16) (16-inch pipe listed)]. FS Date: 7/13/2018

vent and standpipe visible on LS slope.

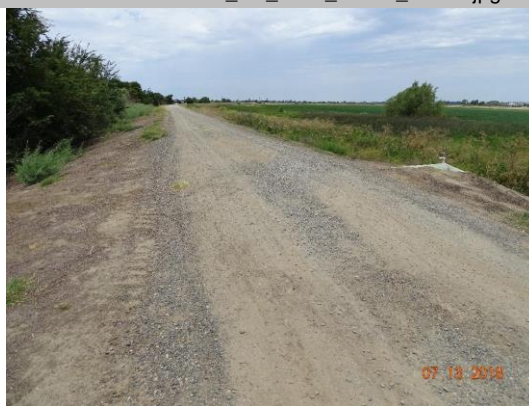
Photo 2 of 3 : UCIP\_SP\_2019\_52767\_77770.jpg

Item	DWR UCIP Field Study			38.136937 °		38.136937 °
				-121.594521 °		-121.594521 °
DWR ID	20170					
Comment Code						
Inspector Comment						
FS_ID:52767 DS_ID:20170 EP_NO: 11217 Repair Type: Non-Urgent Crossing Status: Found UCIP Comments: 06/13/2013 Pipe does not have appropriate clearance at Levee crown. (W.Wylie) FIELD_STRUCT_DESC: 16-inch steel irrigation siphon pipe through the levee, 1 foot below the crown. Air vent/filler pipe on the landside (LS) shoulder. Slide gate in a 5-foot-diameter steel standpipe on the LS toe. (Automatic Board Order (ABO) issued as Permit No. 11217, 1975 - Owen E. Wilkenson). [Additional Reference(s): DWR Levee Log, 2005. USACE Sacramento O&M Manual 103, June 1954, (Station ""L"" 60+34) (14-inch pipe listed)]. FS Date: 7/13/2018

View of levee crown at the crossing.

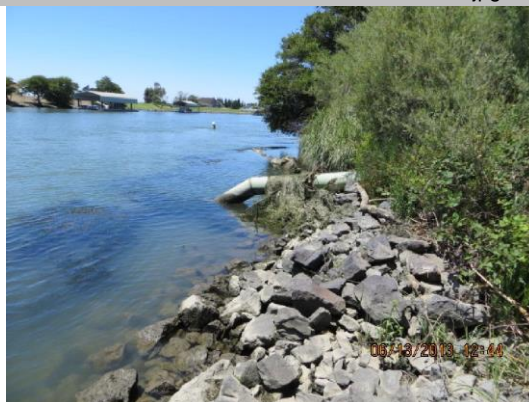
Photo 3 of 3 : UCIP\_SP\_2019\_52767\_24689.jpg

Pipe visible on WS toe.

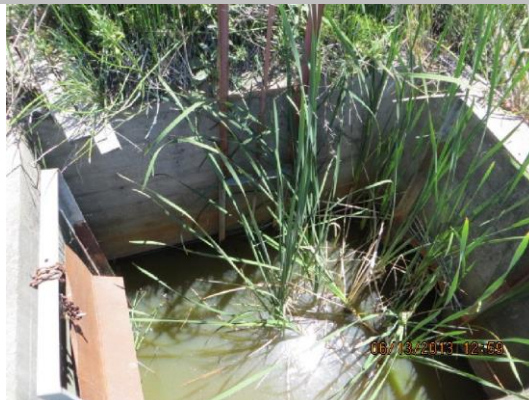
Photo 2 of 3 : UCIP\_SP\_2019\_52769\_24704.jpg

Distribution box and slide gate visible on LS toe.

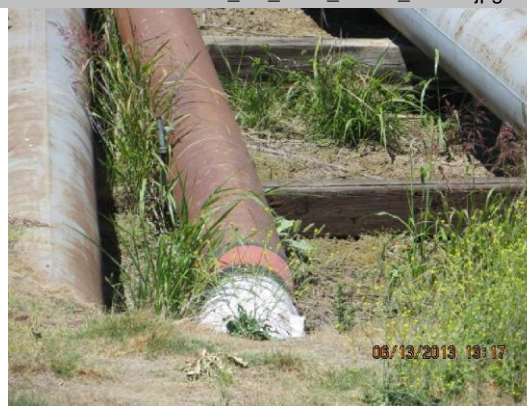
Photo 2 of 3 : UCIP\_SP\_2019\_52771\_24730.jpg

LM Start	12.00	Rating **	A/W	Issue No.	806 (cont)	
LM End	12.00	Issue Type +	Ma	Location *		
Category	Supplemental			GPS Latitude/Longitude		
				Start		End
Item	DWR UCIP LMA Responsibility			38.130726 °		38.130726 °
				-121.579646 °		-121.579646 °
DWR ID	20172					
Comment Code						
Inspector Comment						
FS_ID:52771 DS_ID:20172 EP_NO: 11213 Repair Type: No Action Needed Crossing Status: Found UCIP Comments: FIELD_STRUCT_DESC: 20-inch steel drainage pipe through the levee, 1 foot below the crown. Pump on the landside (LS). Siphon breaker on the waterside (WS) shoulder. (18-inch pipe [HLM 12.28] at a depth of 4-feet authorized under Automatic Board Order (ABO) issued as Permit No. 11213, 1975 - Reclamation District No. 563). [Additional Reference(s): DWR Levee Log, 2005. USACE Sacramento O&M Manual 103, June 1954, (Station ""L "" 6+48.9)]. FS Date: 7/13/2018

20-inch pipe on LS toe.

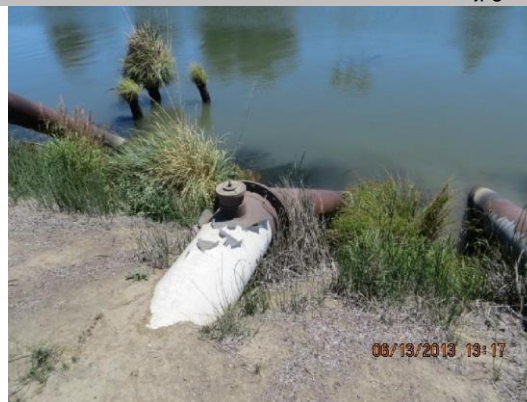
Photo 3 of 3 : UCIP\_SP\_2019\_52771\_24729.jpg

Pipe and siphon breaker on WS shoulder.

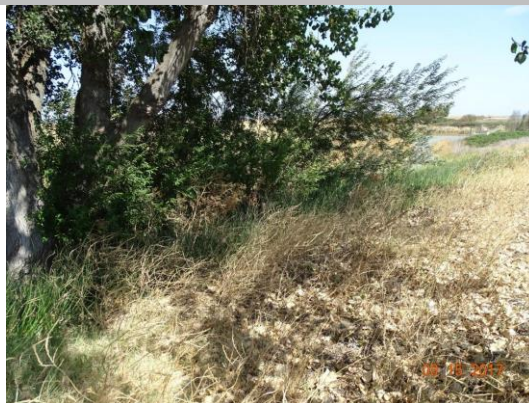
Photo 1 of 2 : SP\_2019\_RD0563\_210\_47\_20190311\_00018.jpg

LM Start	12.04	Rating **	M	Issue No.	47
LM End	12.04	Issue Type +	Ma	Location *	LS
Category	Earthen Levee			GPS Latitude/Longitude	
				Start	End
Item	Trim / Thin Trees			38.130758 °	38.130758 °
				-121.579027 °	-121.579027 °
DWR ID	DWR_RD0563_01_s_2012_47				
Comment Code					
T1 : Trim trees to at least five feet above ground level.					
Inspector Comment					
Trim tree on landside slope.

Looking northeast at the landside slope.
